Perforation of Left Ventricular wall and Ipsilateral Pleura by a Right Ventricular Pacemaker lead: Case Report

Citation: Cristina Viscogliési, Dario Buioni, Paolo Nardi, Calogera Pisano, Eleonora Latini et al., (2024), Perforation of Left Ventricular wall and Ipsilateral Pleura by a Right Ventricular Pacemaker lead: Case Report, *International Journal of Clinical Case Reports and Reviews*, 17(1); DOI:10.31579/2690-4861/418

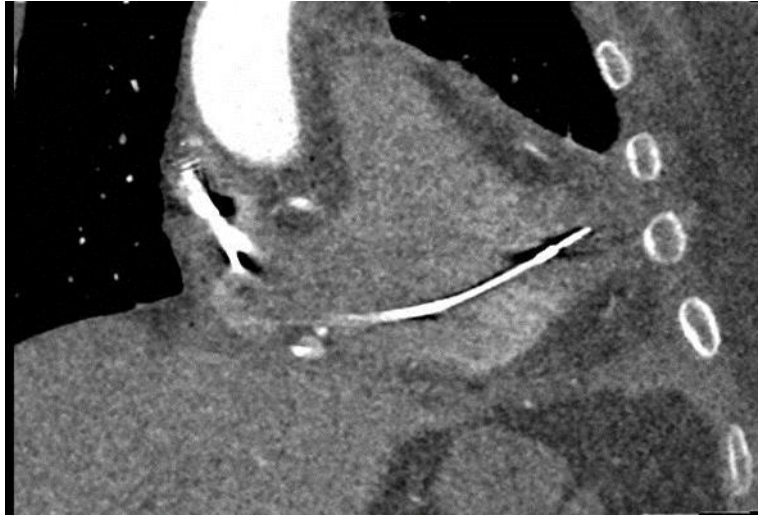
Figure 1: Therefore, after 20 days from the first, she was subjected to an operation of PMK repositioning under general anesthesia with transesophageal ultrasound monitoring.

After surgery, she underwent cardiac CT (Figure. 1) which showed the tip of the ventricular lead projecting outwardly passing the antero-septal wall at the apical level and coming into close contact with the parietal pericardium at that level.

During the intervention, after the sternotomy, an important quantity of frankly blood liquid was aspirated and the clot on the anterior wall of the ventricle was removed. The electrode-catheter was 5 mm out of the left ventricle, about half a centimeter from the course of the anterior

descending artery. Repair was carried out with a U point in polypropylene 4-0 reinforced with double pledgets and application of pericardium patches with Coseal glue and Tabotamp. The left pleura was opened to drain the pnx.
