Intraoperative Innominate Vein Perforation Due to Malpositioned Central Venous Catheters: A Dual Hazard with Fatal Outcome

This case report aimed to present a rare but fatal instance of intraoperative vascular perforation caused by malpositioned central venous catheters

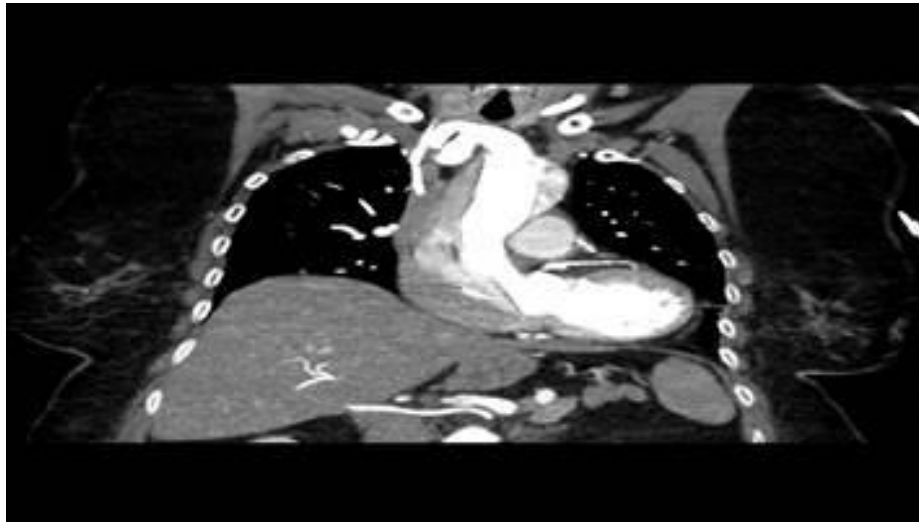
Figure 1: Chest CT Angiography, Coronal View showed a Type A aortic dissection within an aneurysmally dilated aorta.

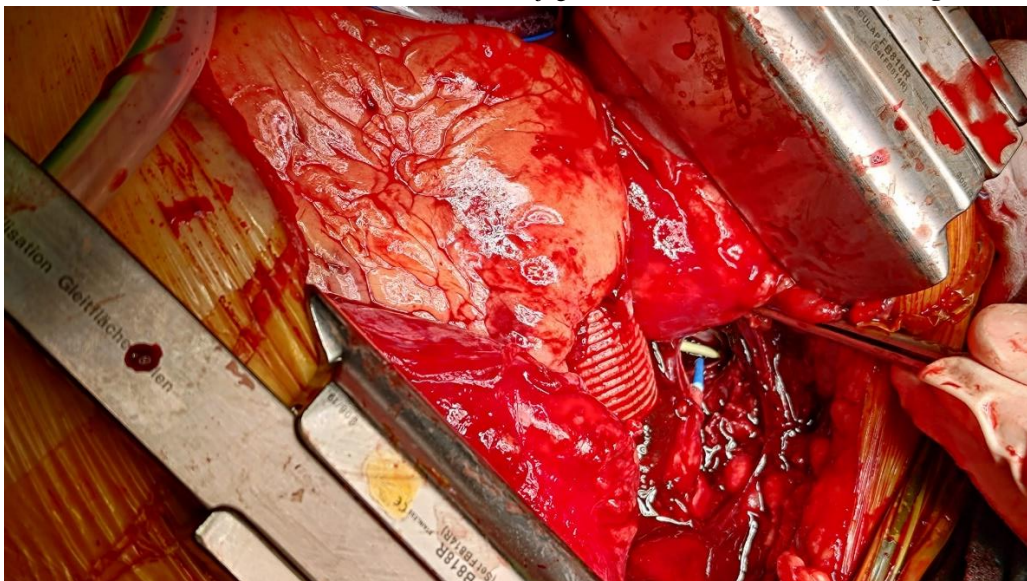
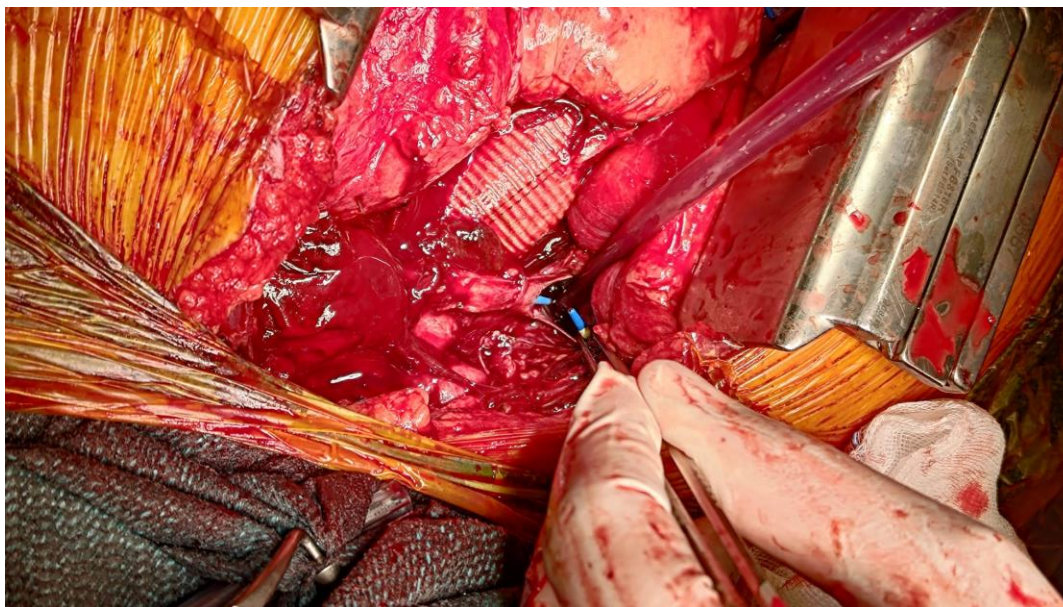
During sternal wiring, sudden massive venous bleeding occurred. Re-exploration revealed a large defect (approximately 2 cm × 2 cm) between the left brachiocephalic vein and the superior vena cava, located in close proximity to the tips of the two malpositioned inserted CVCs (right internal jugular vein and left subclavian vein) (**Figure. 2 and 3**).

Figures 2 and 3: Intraoperative view showing a large venous defect at the junction of the left brachiocephalic vein and the superior vena cava. The tip of the central venous catheters (**white** and **blue**) is visible near the site of injury.

Manual compression was applied to the defect and the superior vena cava to achieve hemostasis; however, this maneuver led to the complete functional loss of venous access in a critically catecholamine-dependent, vasoplegic patient.

Schummer et al. proposed an anatomical zoning system of the central venous system—Zone A (lower SVC to upper right atrium), Zone B (upper SVC to the confluence of the innominate veins), and Zone C (left innominate vein). For safety, right-sided catheters should terminate in Zone B, while left-sided catheters should only be placed in Zone A. Placement in Zone C is discouraged due to higher complication risk as seen in our case (**Figure. 2 and 3**) [7].

A probable contributing factor to the vascular perforation in this case was an intraoperative incident where the infusion pump signaled a high-pressure alarm. In response, manual manipulation of the catheter, specifically attempts to adjust its position, was performed to restore function without confirming proper tip placement. Given that the catheter tips were already lodged in a thin-walled venous segment, such manipulation may have exacerbated mechanical stress on the vessel wall, ultimately resulting in perforation as depicted in **Figures 1 and 2**.
