Periprosthetic Comminuted High Energy Fracture of The Proximal Femur Three Months After Primary Total Hip Arthroplasty in Young Male. A Case Report

Citation: Erceg D., Erceg M., Bečić K., Bekavac J., (2023), Periprosthetic Comminuted High Energy Fracture of The Proximal Femur Three Months After Primary Total Hip Arthroplasty in Young Male. A Case Report, *International Journal of Clinical Case Reports and Reviews*, 16(1); DOI:10.31579/2690-4861/348

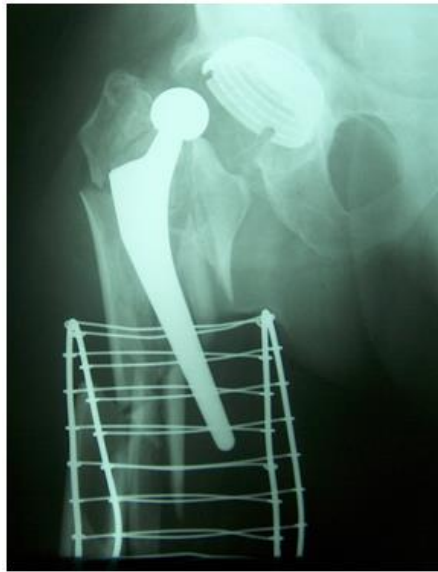
Figure: 1

Figure 1: X ray of the right hip and proximal femur shows comminuted periprosthetic femoral fractures 3 months after total hip replacement. **Figure 2:** X ray of the left hip with fractures of acetabulum and ischial bone.

Male patient B. B., born 1970. had a traumatic dislocation of the right hip in car accident in 1990. After transsosal traction closed reduction of the right hip was done, but paresis of peroneal nerve existed till today. In March 2010. patient underwent surgery procedure for uncemented THA of the right hip, because of secondary posttraumatic hip arthrosis. Three months after hip arthroplasty the patient had a new car accident and he had traumatic dislocation of the hip prosthesis with periprosthetic comminuted fractures around and below the femoral stem. The stem was completely loose, while the acetabulum was well-fixed (Figure 1).

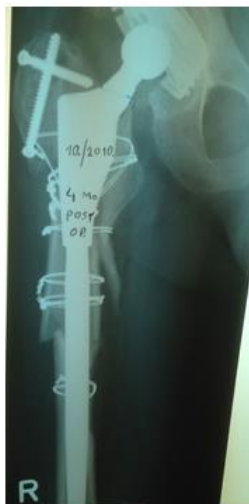
Figure 3

Figure 3: X ray of the right hip and femur bone 4 months after rearthroplasty and osteosynthesis. **Figure 4:** X ray; long cementless femoral stem. **Figure 5:** X ray 7 years after rearthroplasty.

The patient underwent surgery on his right hip and thighbone. Loosened femoral stem of prosthesis was removed. We found many femoral bone pieces, some of them were free of soft tissues and some were very small. Such pieces of bone have to be thrown out. First we implanted revisional uncemented long femoral stem in distal femoral fragment, and all other fragments were placed around femoral stem, keeping them together with seven cerclages and two screws. Some parts of femoral stem were not covered with bone, because some fragments were so small that we could not fix them (Figure 3,4). Femoral stem was firm in distal fragment and after reposition, prosthesis was stable, but the leg became shorter. In postoperative time everything was going fine, only weight bearing was delayed. Later on we did not see the patient for seven years, because he lives and works outside of Croatia. When we met him again he gave us X rays of his both hips (Figure. 5,6). The patient uses orthopaedic shoes with

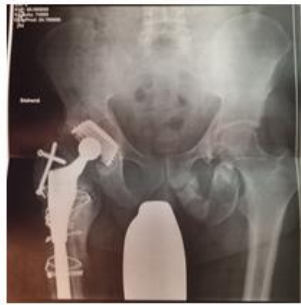
Figure 6

Figure 6: X ray of the pelvis 7 years after rearthroplasty of right hip. Pseud. **Figure 7:** Good function of the right hip and knee joint. oarthrosis of the left ischial bone (ischial body and ischial ramus is seen). **Figure 8:** Good function of the right hip and knee joint.
